Engine Performance: Benchmarking Through Spark Plug Analysis

By A. R. Brenholts Jr.

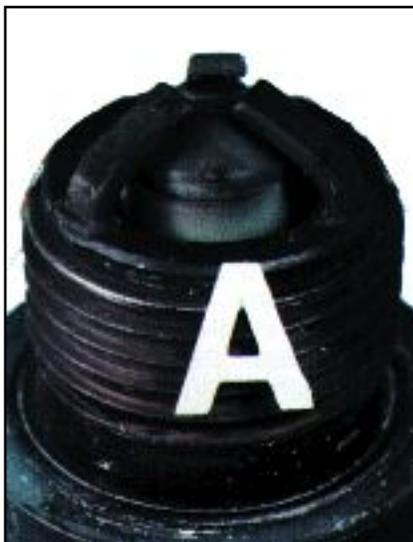
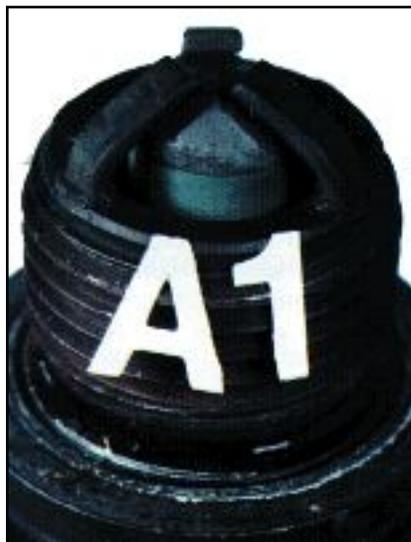
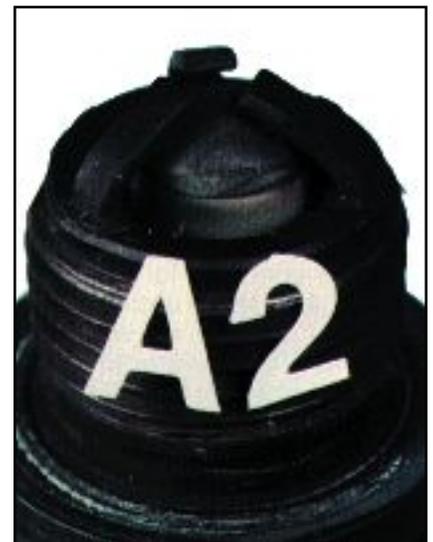
CASE A

The plug in Case A is one of a set of 12 that had operated for approximately 2000 hours in a naturally aspirated, four-stroke cycle, natural gas fueled, stationary, V-angle, 12-cylinder engine driving a separable compressor at approximately 1000 rpm.

The abnormal (blue) deposit on "A1 " is rarely observed as a spark plug deposit coloration, but, in this instance, five of the 12 spark plugs exhibited this coloration.

As a rule, only the metallic element, cobalt, can cause a blue coloration that will endure the elevated temperatures of combustion. Cobalt is not a constituent of any firing-end component of this spark plug. This spark plug's deposit coloration then, is a warning that some engine component may be experiencing high temperature wear that might progress to catastrophic failure. In response to the observation of this coloration (as well as to other exceptional deposits), we would recommend a borescope examination of the involved power cylinders, and possibly the quantitative analysis of the deposit material for a clearer resolution of all the excessive wear-involved components.

conducted upon the turquoise material deposited in photo "A1 ", revealed this chemistry in approximate volume: 39% aluminum, 21% cobalt, 24% chromium, 8% iron, 1 % nickel, 5% phosphorous, and 2% calcium. Excepting the phosphorous and the calcium, which are typically lube oil-derived elements, the principal constituents are metallics, probably introduced in the process of abnormal wear. The next step would be to isolate wear-subjected engine components fabricated from these elements and respond accordingly.

The four other spark plugs of this engine set, which displayed a similarly blue-colored deposit, exhibited virtually identical deposit chemistries. Though we cannot establish these spark plugs in the time frame of the wear process, within the week after these spark plugs had been removed and shipped to us, the engine experienced catastrophic component failure. We suggest that a routine inspection of spark plugs being removed from service might have caught this wear trend at an earlier stage, creating the opportunity for the corrective actions to arrest the abnormal wear trends . . . or, to turn unscheduled downtime into scheduled downtime.

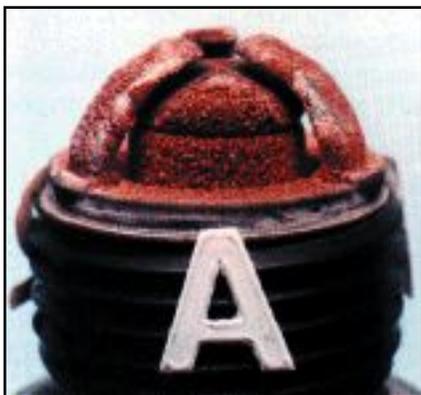
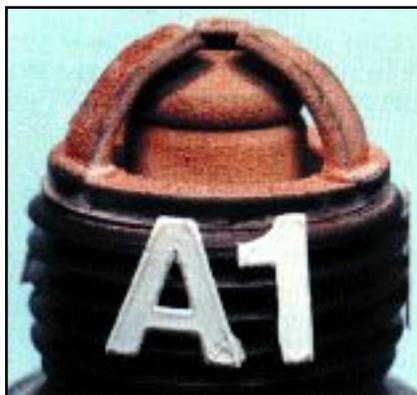
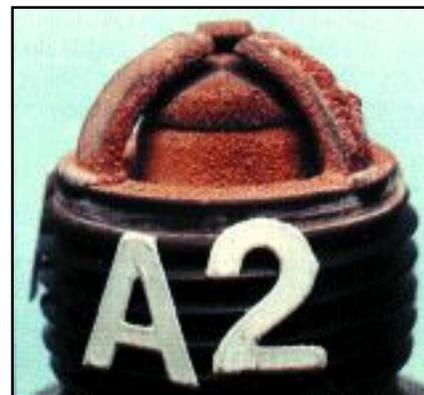
CASE B

This plug was returned to us as one of a set of 16 that had operated for only 200 hours in a turbocharged, four-stroke cycle, low Btu digester gas fueled, stationary, V-angle, hot water cooled, 16-cylinder engine driving a generator at 1200 rpm.

The volume of red-colored, crusty ash is extraordinarily large for such few operating hours. Virtually every spark plug from every cylinder exhibited a similar deposit volume and appearance. Because the engine is a four valve, crossflow design with a central spark plug placement, the asymmetrical concentration of deposit material indicates that it was fuelborne. The area of the spark plug firing-end with the heaviest deposit concentration is typically facing the intake valves. Unless the subject engine's lube oil consumption has been abnormally

excessive, we would find it almost impossible for this volume of deposit to occur in such a short time.

A quantitative analysis revealed the following chemistry in approximate concentrations: 12% phosphorous, 52% calcium, 10% zinc, 19% sulfur, and 7% iron. The phosphorous, calcium, zinc, and sulfur can be identified as lube oil elements. But the deposit is comprised of a large volume of sulfur in the sulfide state, quite often indicative of hydrogen sulfide in the fuel gas. If this were the case, then the iron could be the result of hydrogen sulfide-aggravated corrosion in the fuel delivery system.

In conversations with the engine operator, it was confirmed that the fuel gas was unprocessed, unconditioned

and that the possibility for high concentrations of hydrogen sulfide existed. This could not be confirmed, though, as no fuel gas analysis had been made. It was confirmed, however, that the engine was not being operated with any lube oil anything like the lube oil the deposit chemistry suggested was being introduced into the power cylinders. More to the point, the operator could not confirm any excessive rates of lube oil consumption for the engine.

The source of the operating problem was pinpointed when the operating personnel remarked that the only device consuming excessive amounts of lube oil was the compressor which was used as part of the fuel delivery system so as to boost the low Btu gas to the engines. It was eventually confirmed that the fuel delivery compressor and its excessive rate of lube oil consumption was the mechanism responsible for the large incidence of spark plug fouling.

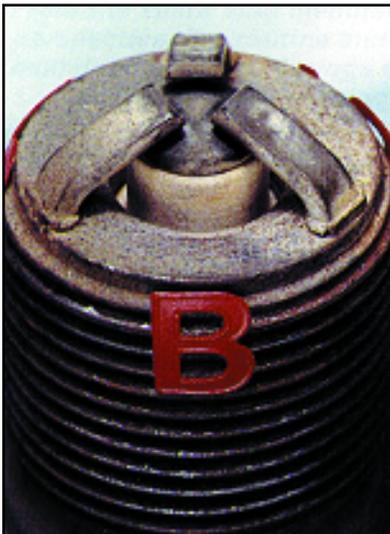
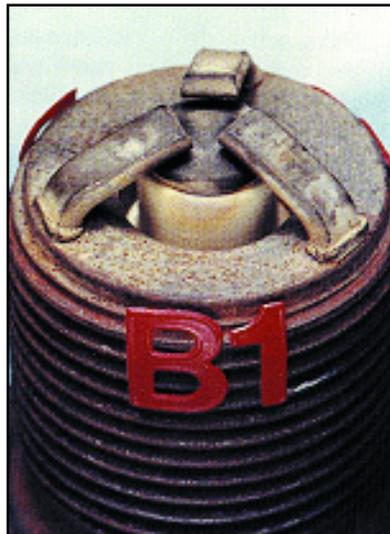
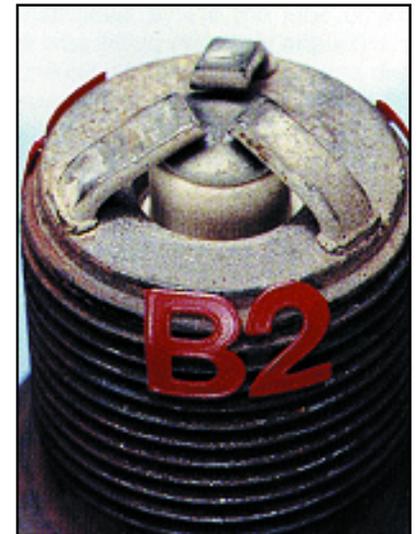
CASE C

This plug was returned to us as one of a set of 12 that had operated for approximately 4000 hours in the fuel cells (pre-combustion chambers) of a turbocharged, four-stroke cycle, stratified charge, natural gas-fueled, stationary, V-angle, slow speed, 12-cylinder, integral compressor engine.

The operating time on these spark plugs was

regarded as normal. The spark plugs were returned to us as part of an engineering evaluation control. We regard this spark plug's firing-end appearance as being typical of so many operating hours with a low ash lube oil, and include it primarily to provide a reference point for the Case A & B spark plugs.
